# NBS SPECIAL PUBLICATION 592

## An Investigation of the Miyagi-ken-oki, Japan, Earthquake of June 12, 1978

On June 12, 1978, a destructive earthquake with Richter magnitude of 7.4 occurred off the east coast of Miyagi Prefecture, Japan. Preliminary estimates by the National Land Agency of Japan indicated that the earthquake caused an equivalent of \$800 million in total damage. There is a cooperative agreement between the governments of the United States and Japan termed the U.S.-Japan Program in Natural Resources (UJNR). Following the earthquake, it was arranged through UJNR that teams of U.S. structural engineers and geologists would visit Miyagi Prefecture and inspect the damage caused by the earthquake. This report assembles the information and collective experiences of the investigation team so as to describe the earthquake and document its effects. Field investigations conducted by geologists and structural engineers are described in detail and some of the implications for seismic resistant design and construction of structures in the United States are also discussed.

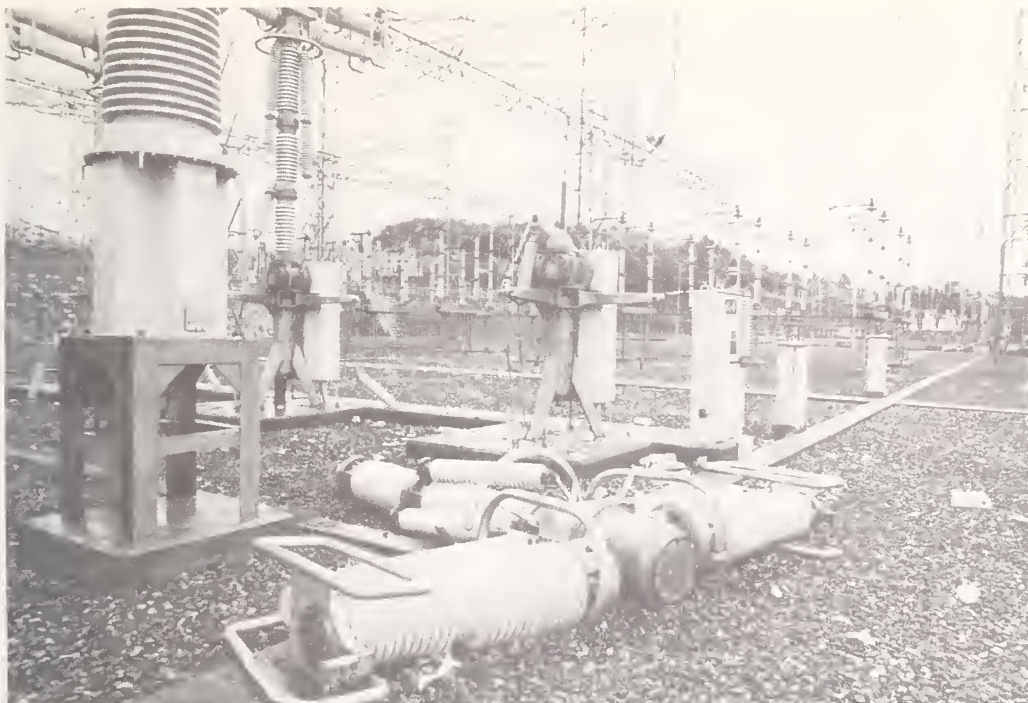
Figure 6.23 Sendai Substation, Izumi: typical damage to 3-phase T-shaped circuit breakers (as shown in previous figure). Note the complete failure of one and the damage to the three guides of the second circuit breaker. All steel supports appear to be undamaged. The photograph was taken immediately after the earthquake before repairs were initiated. (Tohoku Electric Power Co. photograph)

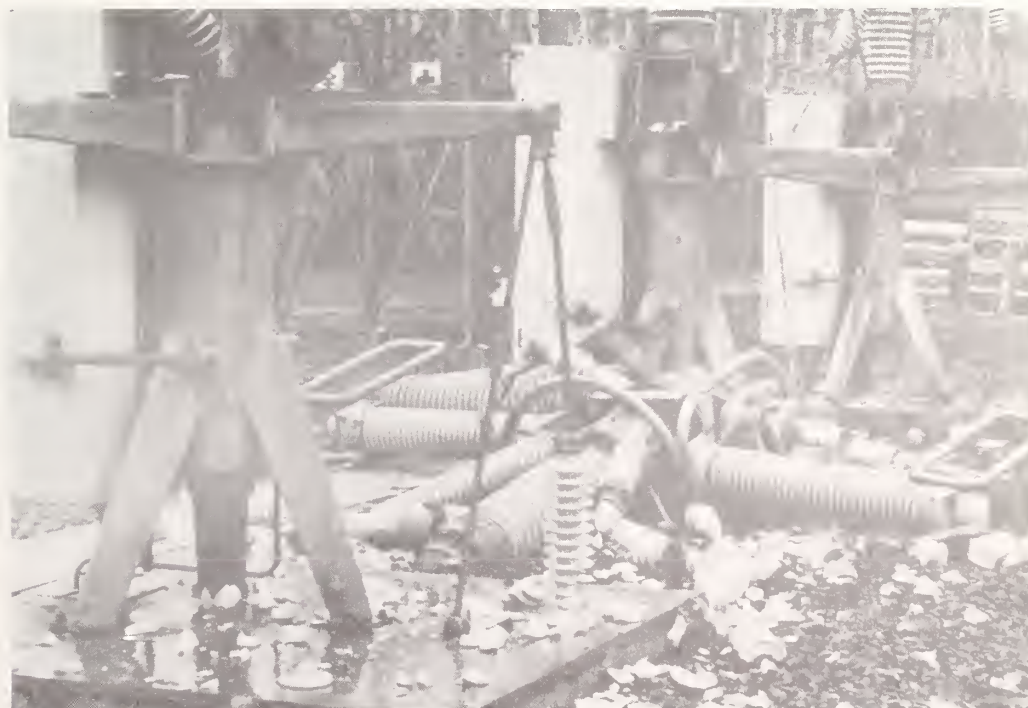
Figure 6.24 Sendai Substation, Izumi: another three failed 3-phase, T-shaped circuit breakers. Note the failed main stems, the loose guide wires and the undamaged steel supports which are attached to their foundations. (Tohoku Electric Power Co. photograph)

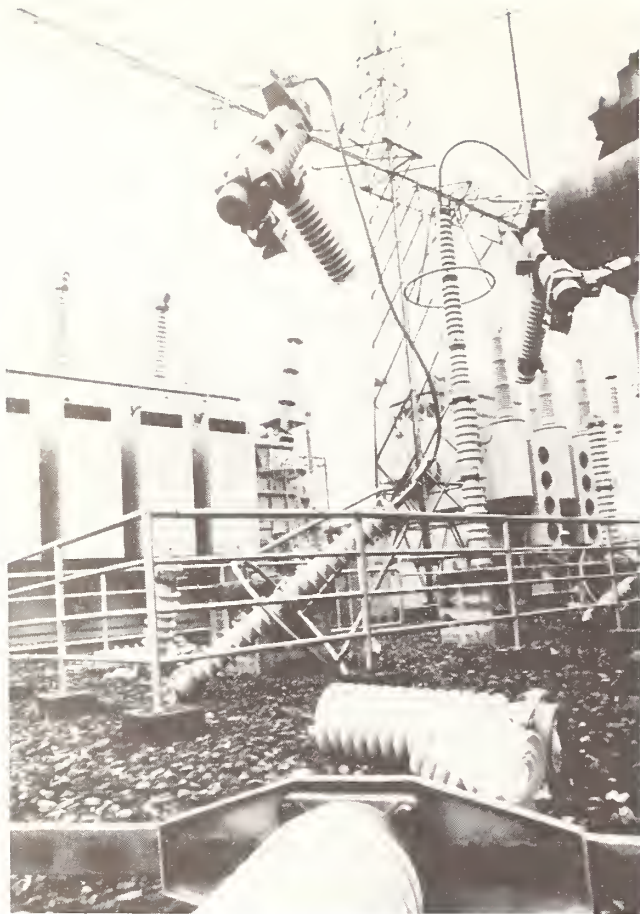
Figure 6.25 Sendai Substation, Izumi: damage to a circuit breaker (right), and two lightening arresters (center). The bushings of the transformer in the background appear to be undamaged; however, the lightening arrester is leaning. (Tohoku Electric Power Co. photograph)

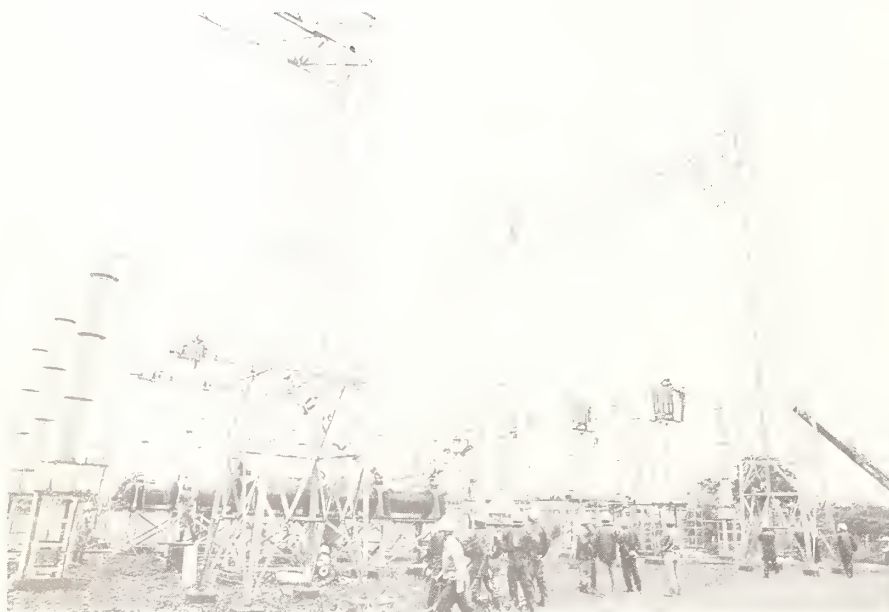
Figure 6.26 Sendai Substation, Izumi: Severe damage to circuit breakers (center of photograph - note the failed columns of live tank design, probably with gas reservoirs), current transformers (with the tapered bushings - some of the stems are also damaged), and reactors (to the left) with presumably broken connections. (Tohoku Electric Power Co. photograph)

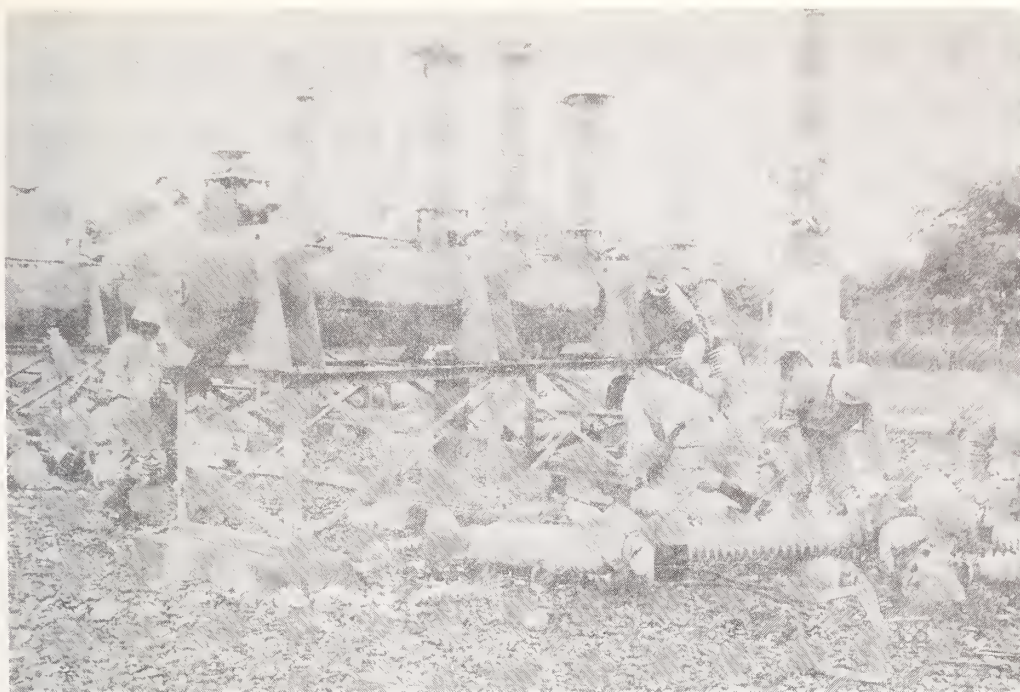
Figure 6.27 Sendai Substation, Izumi. Severe damage to several circuit breakers of live tank design. Note the lack of damage to the structural steel supports and the steel components of the equipment. (Tohoku Electric Power Co. photograph)

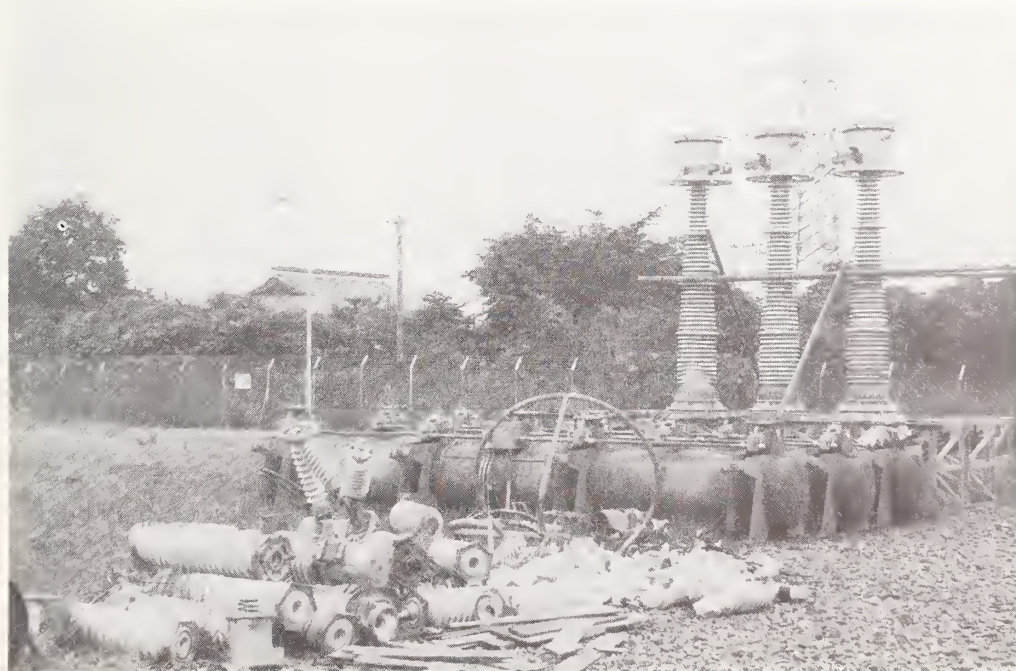
Figure 6.28 Sendai Substation, Izumi; one of several piles of broken equipment, including several line traps or reactors in the back (note the damaged base of the left stem) and the horizontal tanks of several circuit breakers of the live tank type (in the foreground are the failed columns of the circuit breakers and of other equipment).

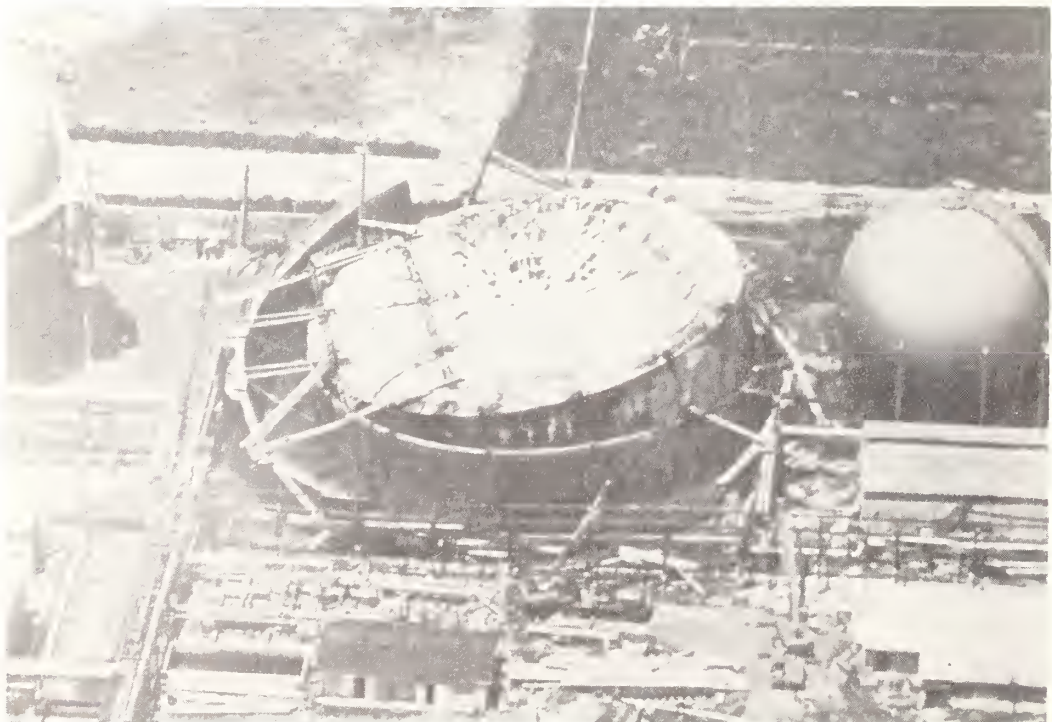
The collapsed holder caught on fire shortly after failure, and all of the stored gas was consumed. The fire burned out, or was extinguished, about 25 minutes later, and did not spread to the nearby high pressure propane tanks. The most serious damage to the gas facility was caused by the collapsing holder. It struck the nearby pipeway for many of the tanks at the plant, causing much damage to the piping systems and other associated equipment. Figure 6.31 shows the collapsed holder and the damaged pipeway just after the earthquake. At the time of the investigation a new pipeway had been erected on the concrete pedestals of the old pipeway, and repairs of the pipelines were proceeding, Figure 6.32. These pipes service the remaining undamaged gas tanks.

Figure 6.30 Haranomachi Plant, Sendai City Gas Bureau: an overall view of a collapsed propane gas holder and some of the surrounding propane storage tanks and affected pipeway and equipment. (Kahoku Newspaper Co. photograph)

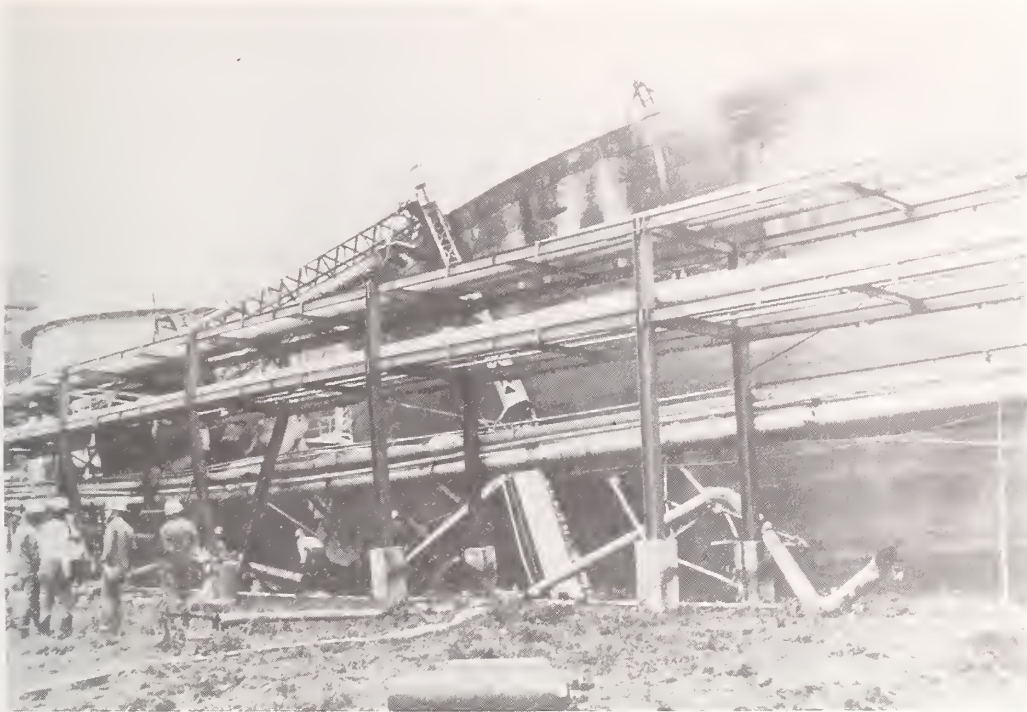
Figure 6.31 Haranomachi Plant, Sendai Gas Bureau; collapsed gas holder and the damaged adjacent pipeway structure just after the earthquake, (Sendai Gas Bureau Photograph)

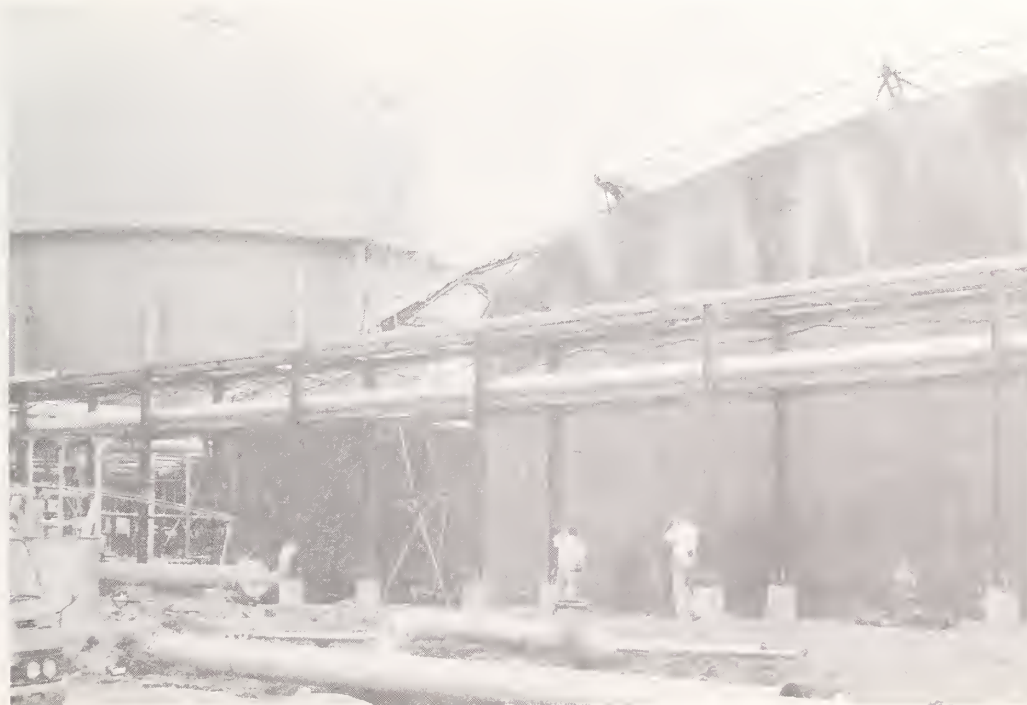
Figure 6.32 Haranomachi Plant, Sendai City Gas Bureau: The newly erected pipeway, with the collapsed holder in the background. Note the undamaged pressurized propane gas sphere in the back.

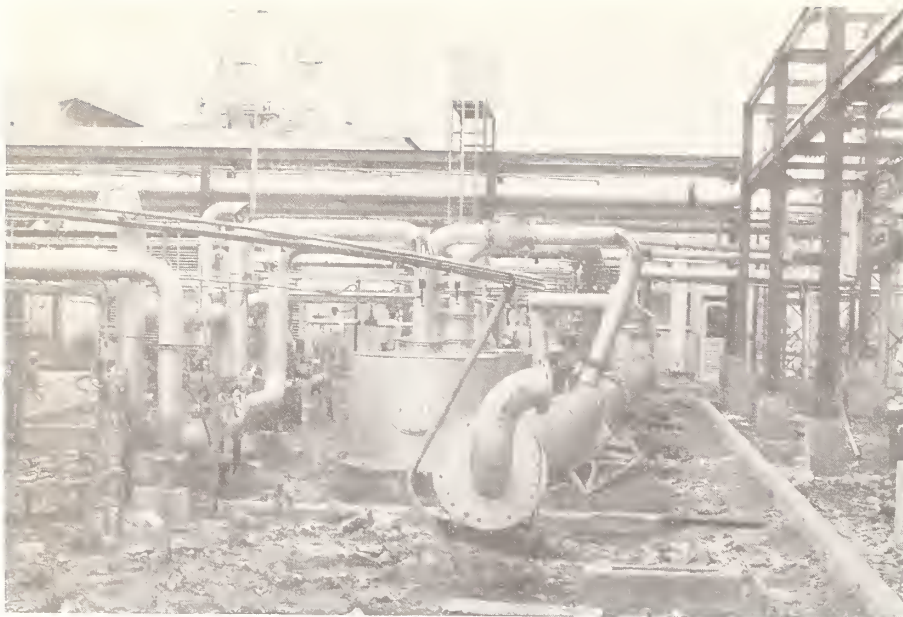
Figure 6.33 Haranomachi Plant, Sendai City Gas Bureau: damage to piping and other equipment and supports caused by impact from the collapsed gas holder and the adjacent pipeway. The newly erected pipeway is to the right.

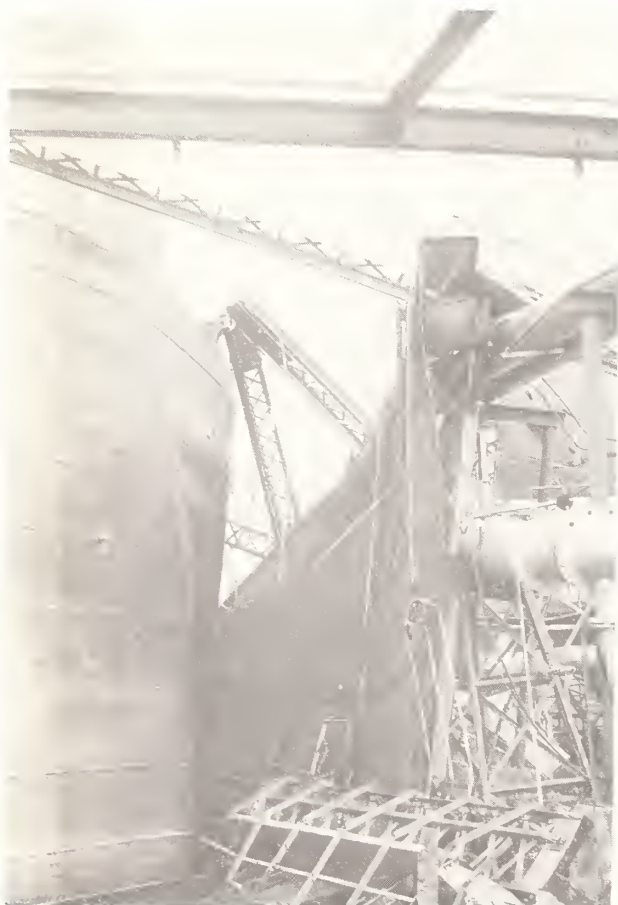
Figure 6.34 Haranomachi Plant, Sendai City Gas Bureau: damage to the telescoping gas holder and to some of the nearby pipeways and equipment. The trusses are portions of the original support structure that had surrounded the tank.

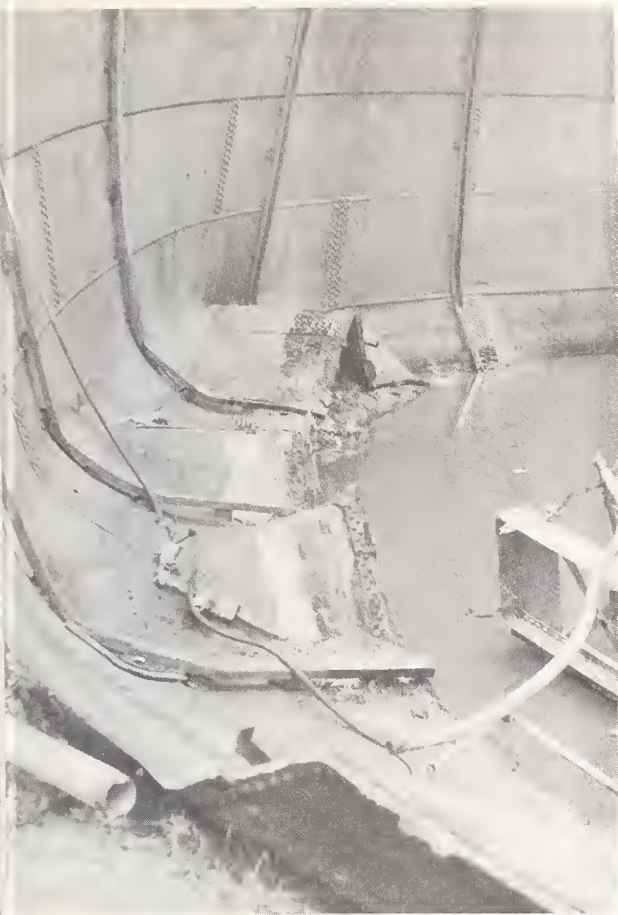
Figure 6.35 Haranomachi Plant, Sendai City Gas Bureau: buckling damage to the lower portion of one segment of the gas holder.

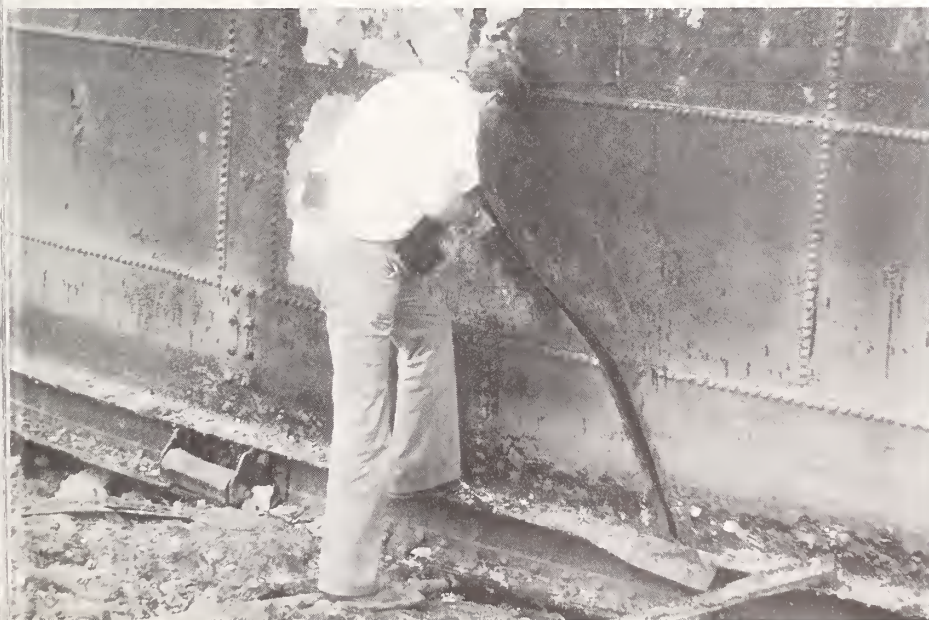
Figure 6.36 Haranomachi Plant, Sendai City Gas Bureau: a fracture of the 3/8-in. plate wall of the collapsed gas holder. The length of the fracture is approximately 1.5 m (5 ft).

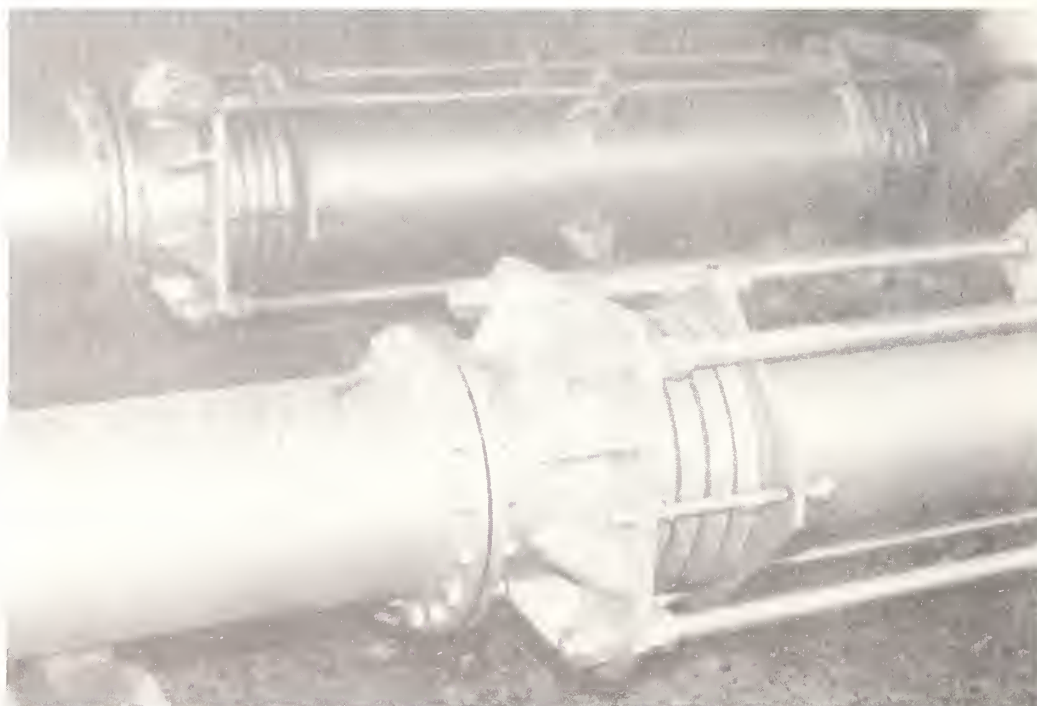
Figure 6.37 Haranomachi Plant, Sendai City Gas Bureau: sheared pipe flange connections in the pipeway structure in the vicinity of the collapsed gas holder.

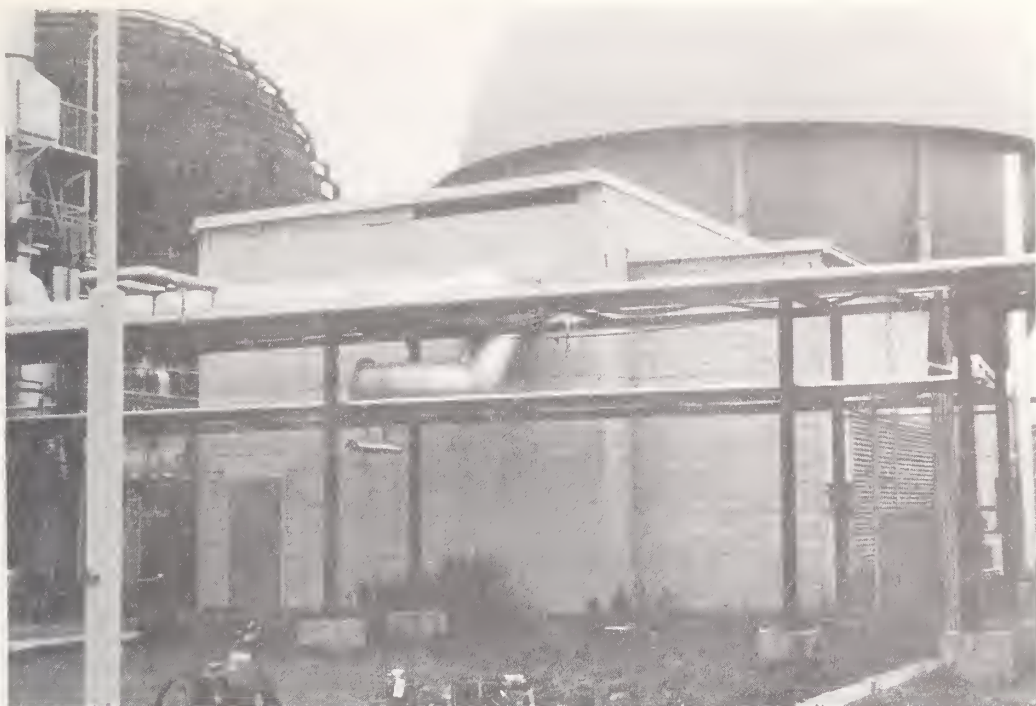
There was evidence of damage throughout the facility (Figures 6.33 through 6.38); however, none of the other tanks at the facility are believed to have suffered major damage. Some damage was due to pounding between buildings and pipes that penetrated the building walls (Figure 6.39). Unanchored pipe supports often moved on their pedestals, and reinforced concrete block structures suffered damage to their structural elements.

Figure 6.39 Haranomachi Plant, Sendai City Gas Bureau: a damaged reinforced concrete block structure. Some of the damage was due to pounding between the large diameter pipe and the structure at the pipe penetration.

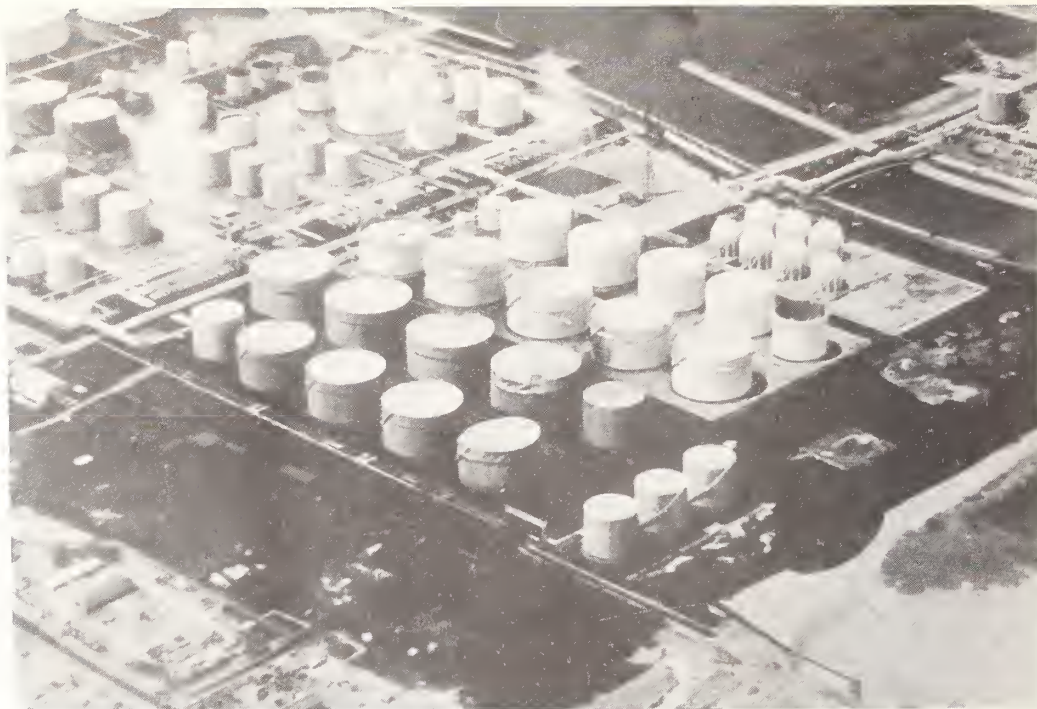
Figure 6.41 Sendai Refinery, Tohoku Oil Company, Ltd.: an overall view of the refinery's tank farm. The spilled oil appears as the dark area of the photograph. (Tohoku Oil Company photograph)

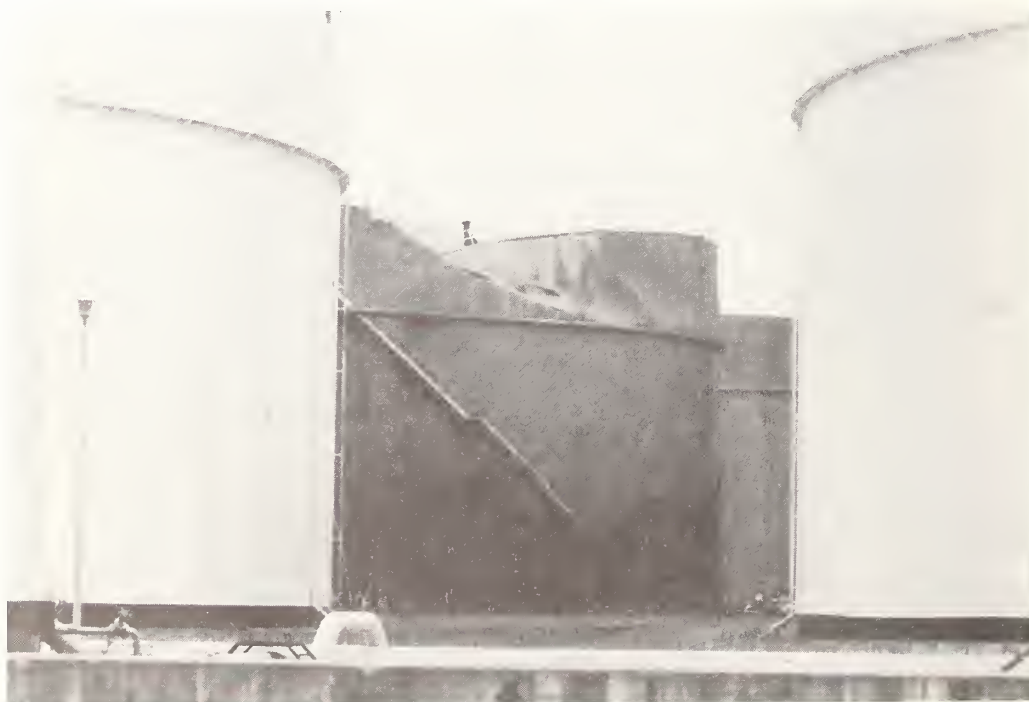
Figure 6.42 Sendai Refinery, Tohoku Oil Company, Ltd.: one of the three failed storage tanks. The damage illustrated is due to suction caused by rapid evacuation of the oil through the ruptured connection of the base and wall of the tank. The several tanks, of similar size, in the foreground are thought to be undamaged.

At the time of the investigation a thick film of oil still covered much of the refinery grounds. Thus, the fire hazard was great, and the investigating team was unable to observe the details of the damage to the tanks. It is believed that the tanks shown in Figures 6.42 through 6.44 failed at their bases. The oil drained rapidly, causing a vacuum inside, which imploded the tanks. Three other tanks suffered damage and will need repair.

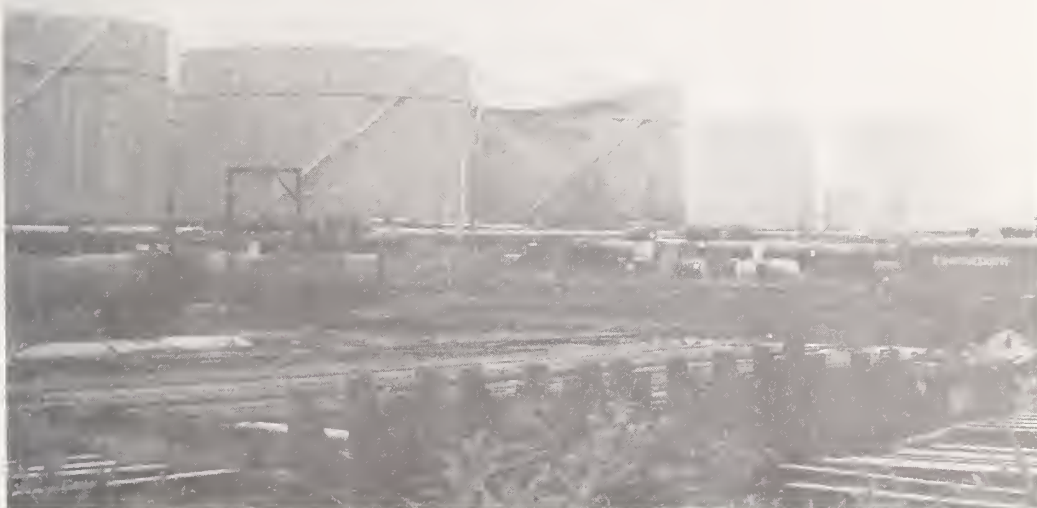
Figure 6.43 Sendai Refinery, Tohoku Oil Company, Ltd. Two other failed TC oil storage tanks.

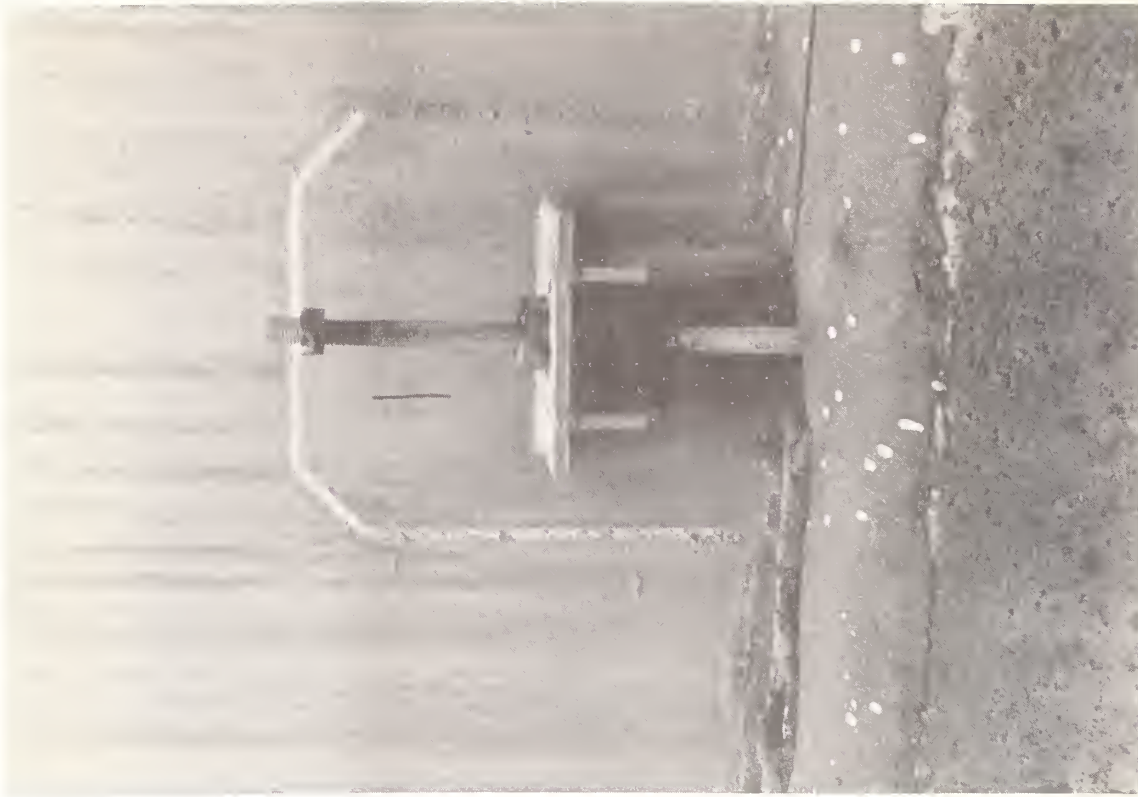
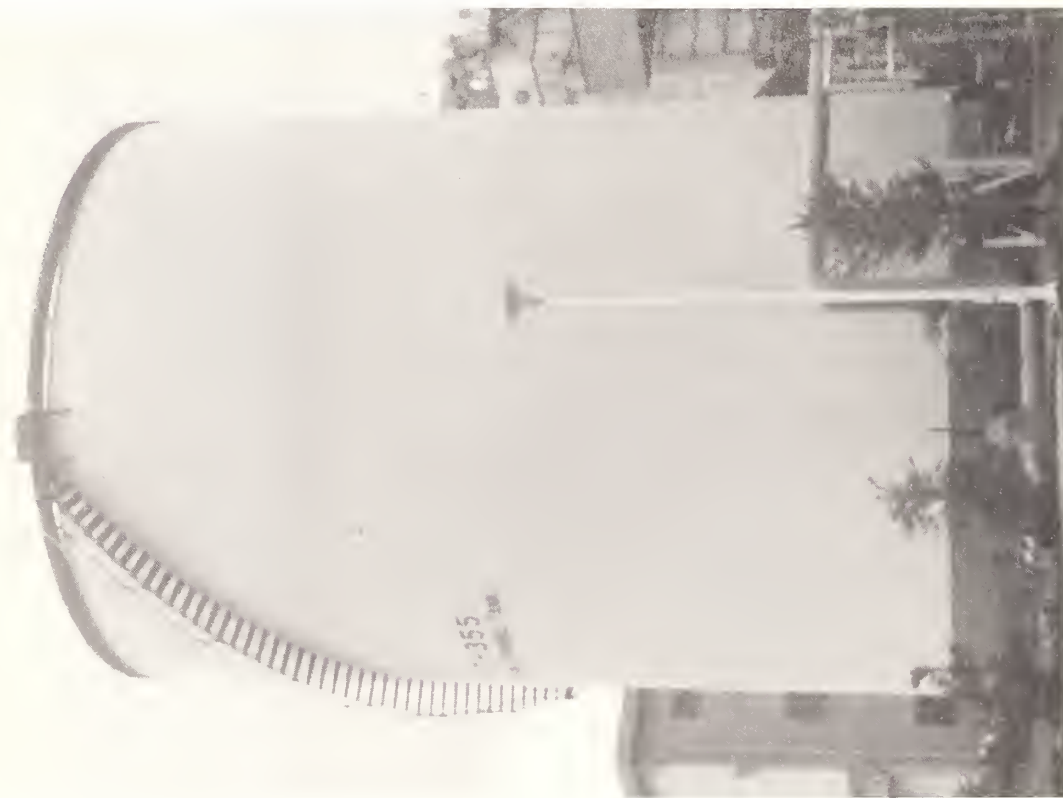
Figure 6.45 Sendai Refinery, Tohoku Oil Company, Ltd. A large water storage tank (left) near the main refinery complex appeared to have experienced significant rocking. Detail (right) of one of the pulled-out, or stretched, anchor bolts of the water storage tanks shown at left.

Another large water storage tank experienced interesting damage (Figure 6.45). The welded steel plate tank was anchored with bolts, spaced at approximately 6 ft (2 m), and embedded in a continuous concrete pad. The bolts around the entire circumference were stretched, or more likely, pulled out from their embedment from 1 to 6 in (2.5 to 15 cm). However, there was no apparent buckling or other damage to the steel base of the tank.

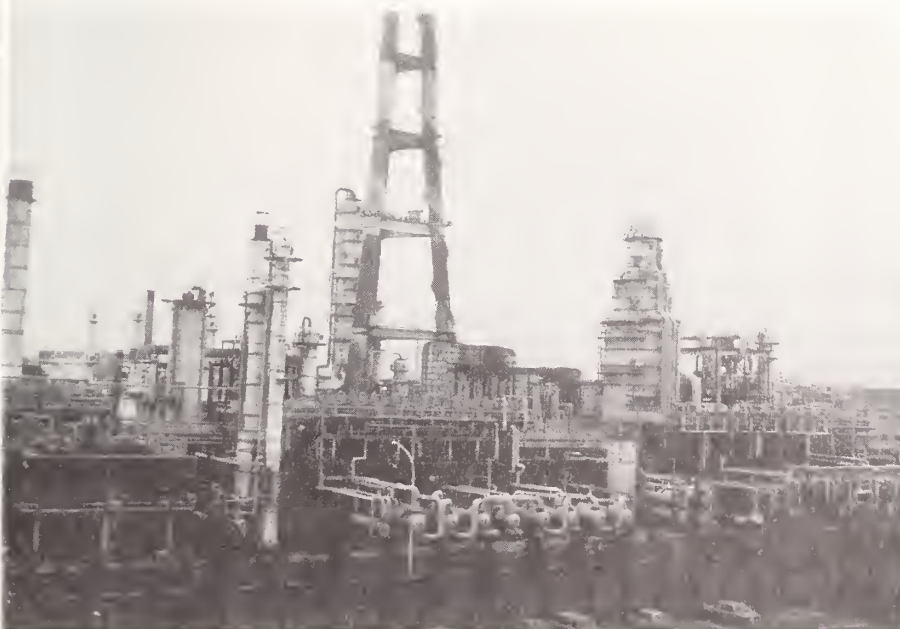
Figure 6.48 Sendai Refinery, Tohoku Oil Company, Ltd.: ground settlement at the refinery.

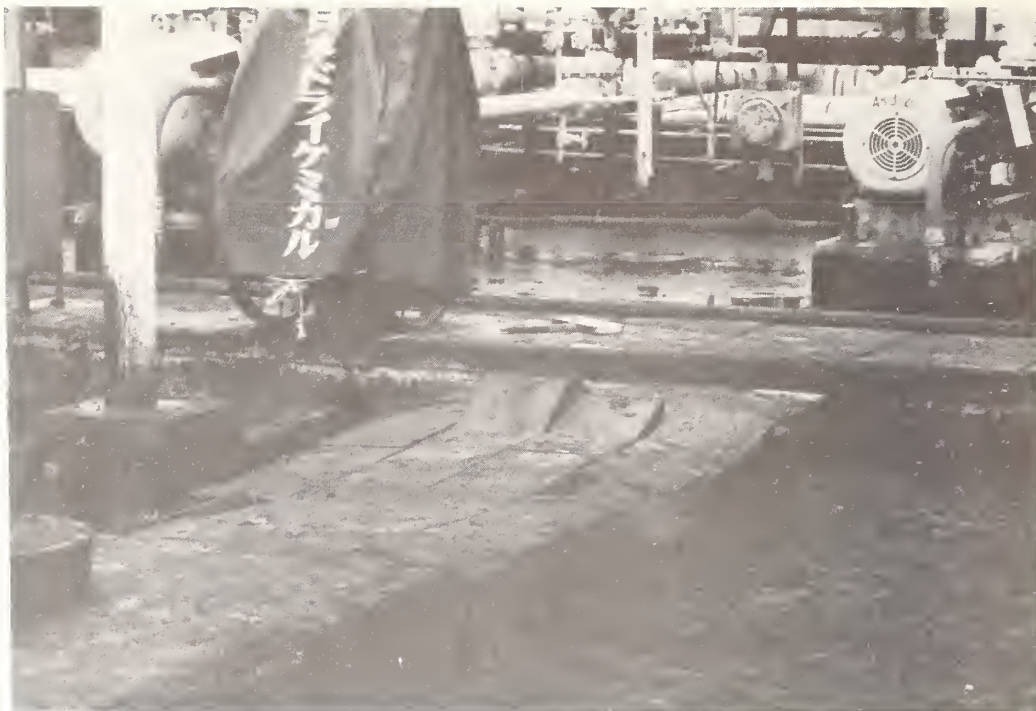
Figure 6.49 Sendai Refinery, Tohoku Oil Company, Ltd.: A wing of the damaged steel-framed administration building. Damage was obvious only to the architectural finishes.

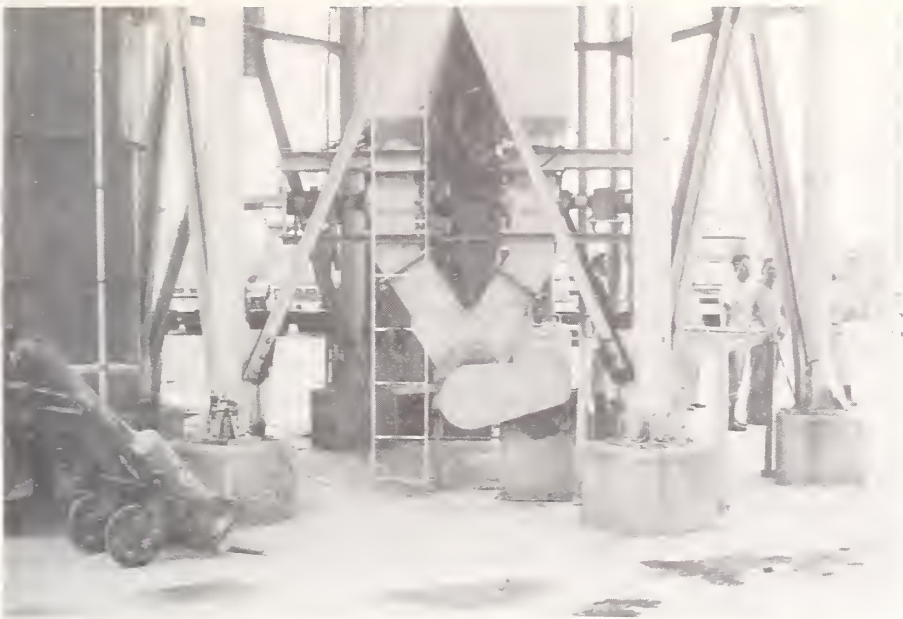
Figure 6.50 Concrete Batch Plant, Sendai: view of the repaired supporting substructure of a cement bin and related equipment. The sheared bolts at the brace connections have been removed and the braces have been welded to the gusset plates. Some of the buckled braces have been replaced entirely.

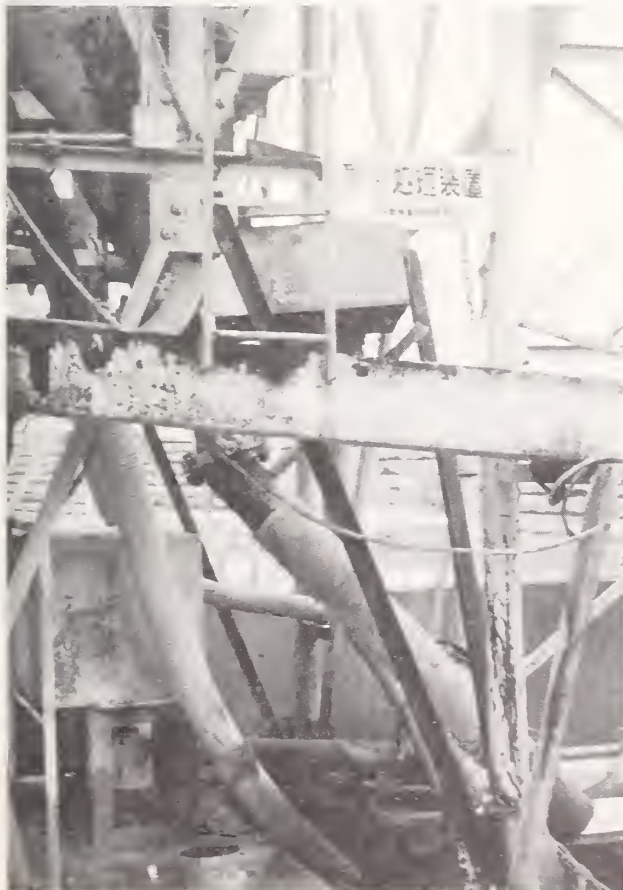
Figure 6.51 Concrete Batch Plant, Sendai: a detail of a replaced, and presumably buckled, diagonal brace. A number of similar repairs were carried out within two days after the earthquake.

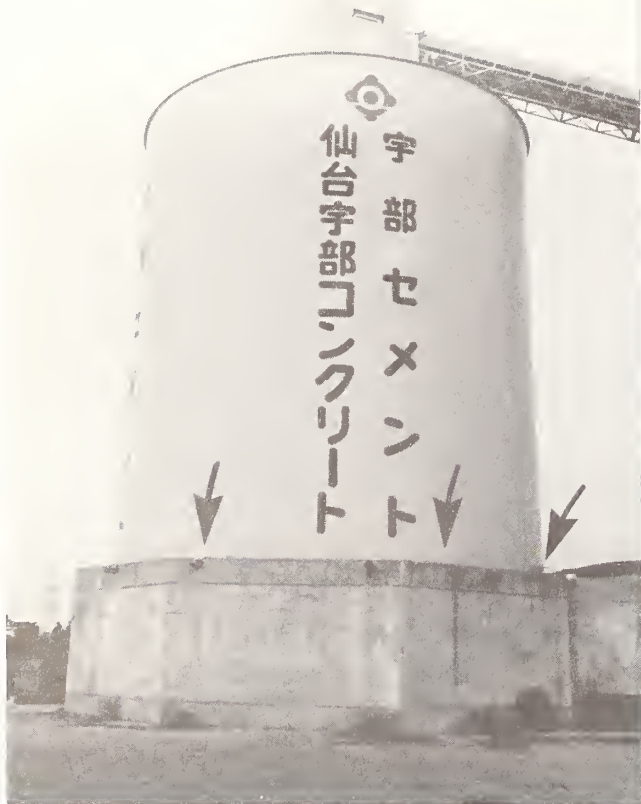
A large welded steel plate storage tank, containing sand and gravel, and reportedly full during the earthquake, which was supported on a massive concrete pedestal, suffered buckling along several locations at the base of the steel plate (Figures 6.52 and 6.53). It seems apparent that the buckling was caused by overturning forces, rather than by sloshing of the contents. The tank and its superstructure and support structure did not experience any other damage.

Figure 6.52 Concrete Batch Plant, Sendai: a large gravel-and-sand-storage tank experienced buckling of the welded steel plate at its base.

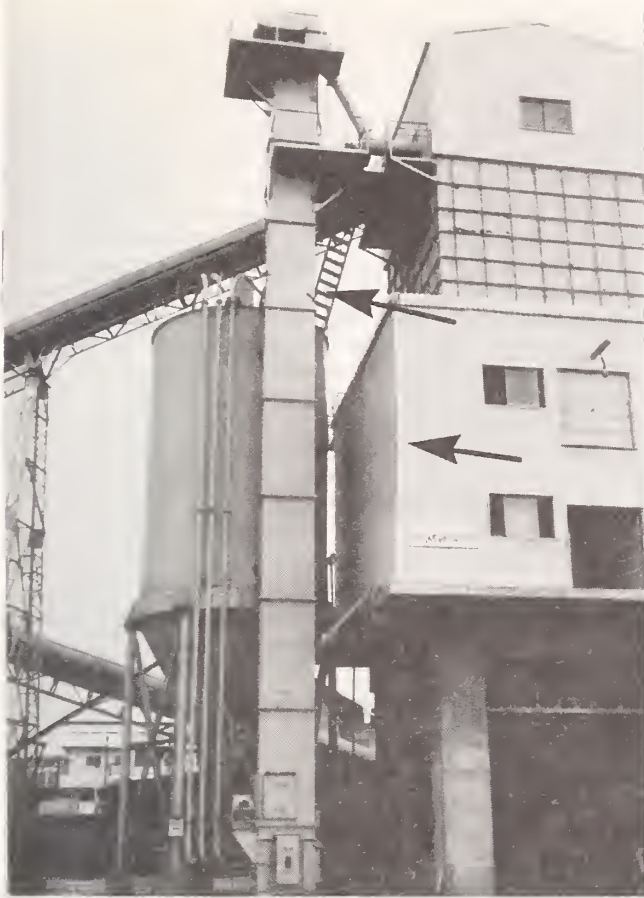
One of the light steel-framed structures at the plant was damaged, as shown in Figure 6.54, apparently because of inadequate lateral bracing. The differential displacement caused by the failure of the structure was responsible for damage to a connecting vertical steel stack and associated piping. The stiffer first floor reinforced concrete structure was undamaged. A similar structure, Figure 6.55, located in the immediate vicinity of the plant and properly braced with light steel cable or rod braces, did not suffer damage. The latter type of construction is quite common in Sendai, and generally appeared to experience no significant damage.

Figure 6.54 Concrete Batch Plant, Sendai: displacement due to damage to the light, unbraced steel superstructure damaged the vertical stack and the conveyor belt structure.

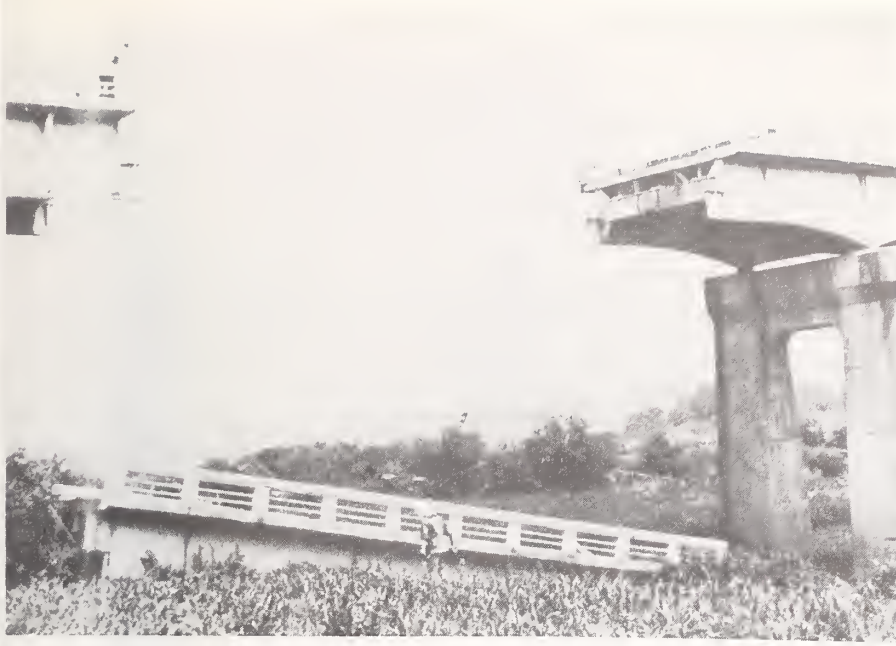
Figure 7.3 Kin-noh Bridge. View of the collapsed suspended plate girder span. Similar damage occurred to bridges in the 1971 San Fernando and 1976 Guatemala earthquakes because of lack of superstructure restraint and small bearing seats. Suspended spans are no longer used in seismically active areas. (Courtesy J.M.O.C.)

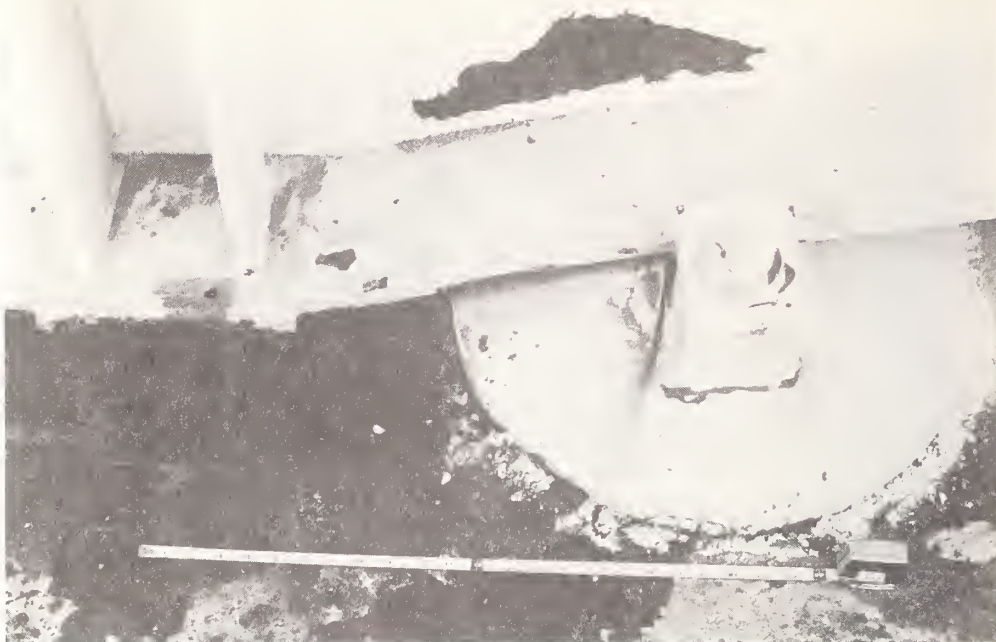
Figure 7.5 Kin-noh Bridge. The girders at Pier 8 displaced longitudinally toward the abutment 55 cm allowing the unrestrained suspended span to drop off the 45 cm hinge seat. The movable girder bearing plate came to rest at the edge of the pier cap. The fixed bearing on Pier 7, the opposite side of the suspended span, displaced longitudinally 0.5 cm.

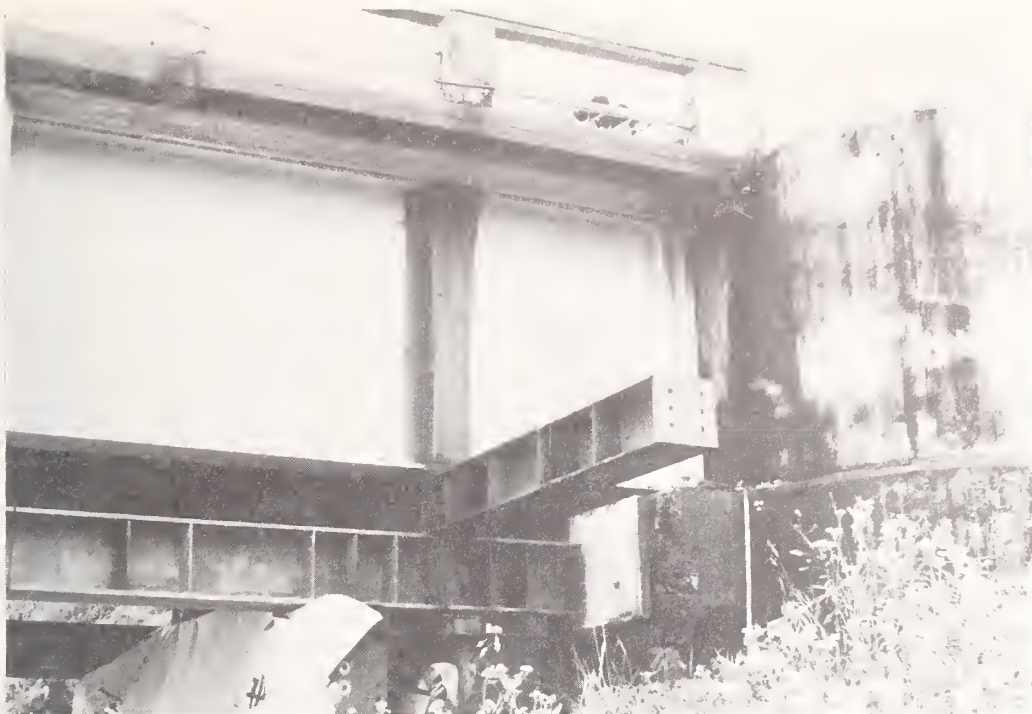
Figure 7.7 Kin-noh Bridge. Damaged abutment from the February 20, 1978, 6.7 magnitude earthquake. New web stiffener at point of temporary shoring.

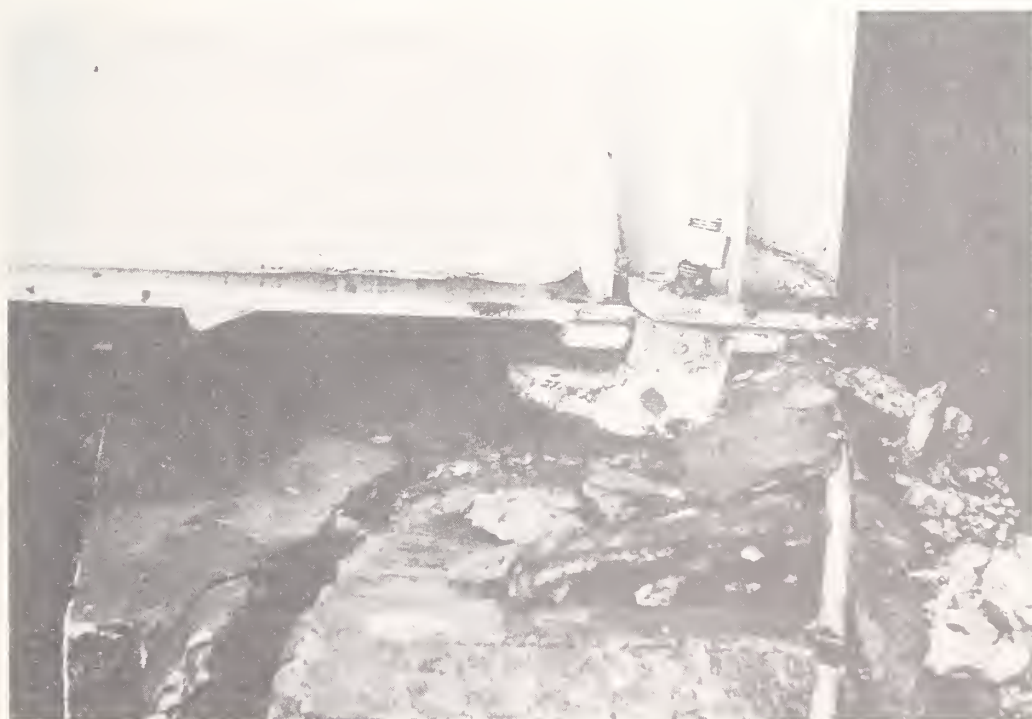
Figure 7.8 Kin-noh Bridge. Detail of bearing damage and abutment ledge failure, from February earthquake. Note extension of anchor bolt caused by 20 cm displacement of span towards abutment.
